# Ram Jack® Case Study

Timber Column Project • Galveston, TX

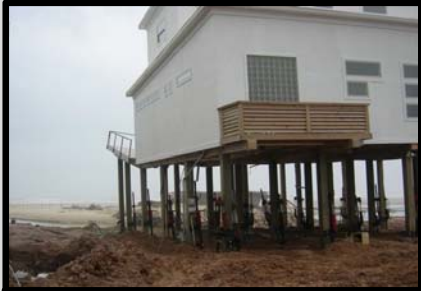
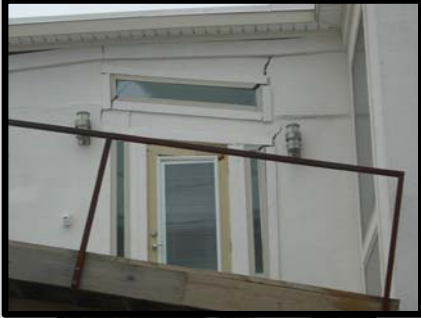
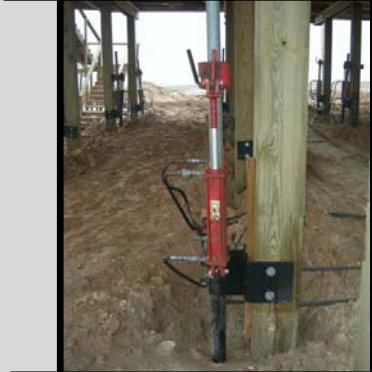
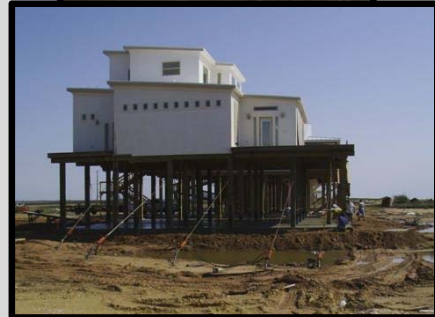
When hurricane Ike hit the shores of Texas, the island of Surfside and Galveston were on the western side of the storm. This is where the surge of water exited back into the ocean taking 5 to 6 feet of sand and dunes with it. The erosion caused catastrophic damage leveling most of the structures on the beach. However, some of the structures survived total collapse but had settled several feet. The home shown to the left had settled 3 to 6.5 feet from its original elevation. The structure had deflected 6 inches at the top of the timber piles.

The home was supported on (32) 10" x 10" square timber piles. A Ram Jack helical pile was installed at each timber pile to a depth of 34'-0". The helical pile was then attached to the timber pile with Ram Jack's timber column bracket. Due to the excessive differential settlement that had occurred, individual lifting of the timber piles was out of the question as it would have created additional racking and stress to the structure. Therefore, hydraulic cylinders were placed at each timber pile and manifolded together with independent controls at each location to provide a controlled uniform lift of the structure. Once the structure had been lifted back to its original elevation, Ram Jack helical anchors were installed and used to pull the structure plumb.
